British Horological Institute

The Portfolio - an example of supplementary work:-

APPRAISAL - Initial Condition of the watch movement and its case

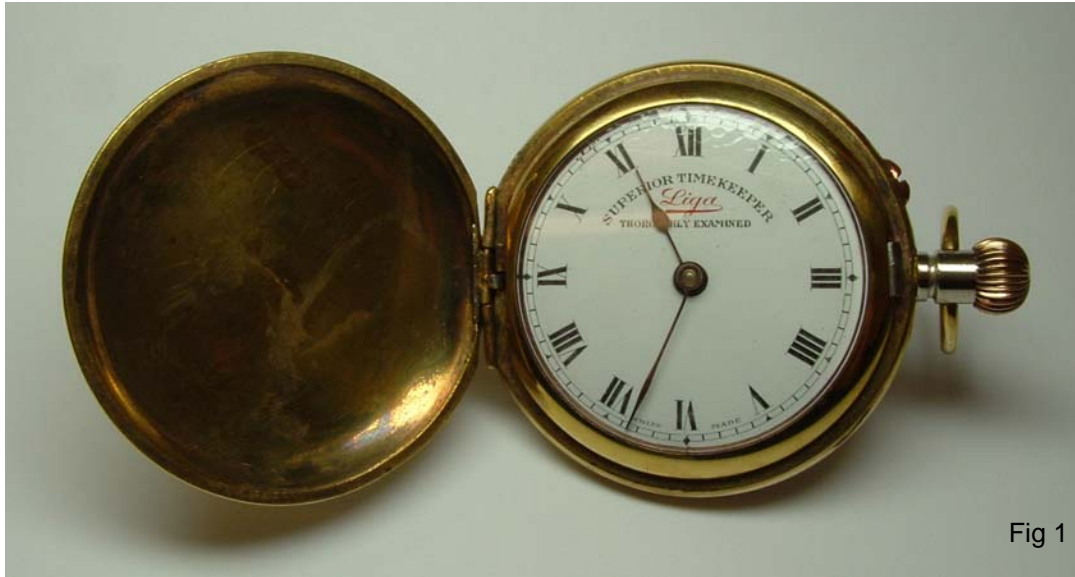
This watch was cased in a brass full hunter case, which although intact was heavily oxidised (fig 1). The dome was engraved “Remontoir Perfectionne, Fabrication Suisse”, although this was barely legible.

Very little work was needed with regards to the case, all parts were intact and functional and the only work undertaken on the case was a light polish, removing oxidation and minor scratches. The dial was left untouched as it was in such good condition and the only other work undertaken was the straightening of the minute hand and the replacement of the dial screw.

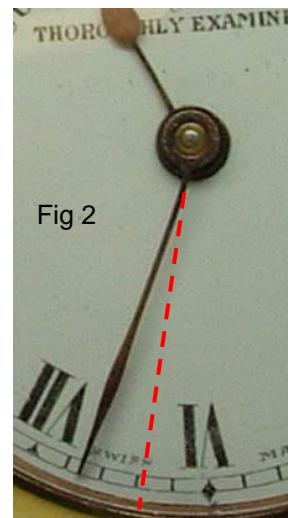
The hands although showing some discolouration were, considering their age, in good condition apart from a slight bend in the minute hand towards the collet (fig 2, the dashed line showing the correct position of the hand).

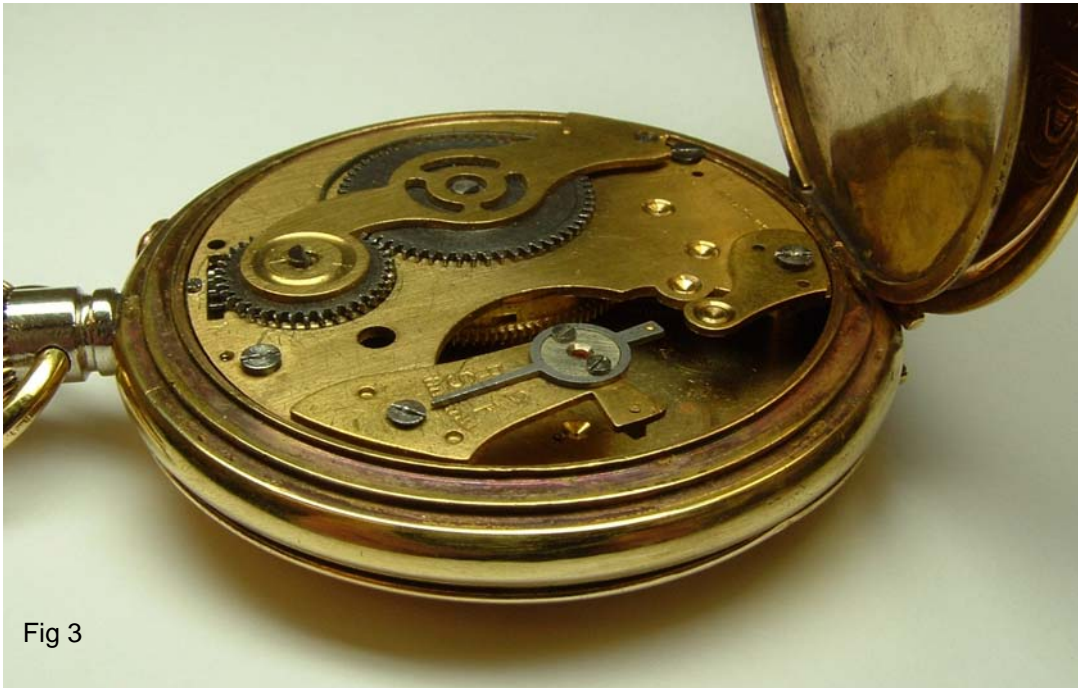
The movement however was not in such a good condition. Fig 3 shows the movement in the condition I received it. It can be seen that besides discoloration the escapement (balance, pallets and escape wheel) is all missing.

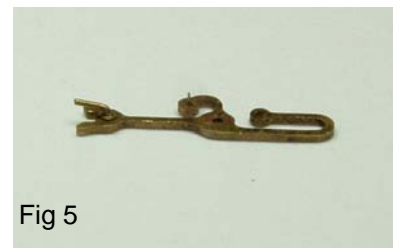
Fig 4

These parts were all separated from the movement and arrived in a small plastic pot. The escape wheel (fig 4) had its lower pivot broken, but besides that was intact and serviceable. The pallets (fig 5) were in poor condition with the staff missing and the exit pallet pin missing. The balance assembly had been dismantled (fig 6), the balance spring was distorted in the round and flat throughout, the staff badly worn with visible wear to both pivots and the impulse finger so badly worn it only occupied half of the space in the notch of the lever. The rim of the balance was oxidised but showing no signs of other damage.

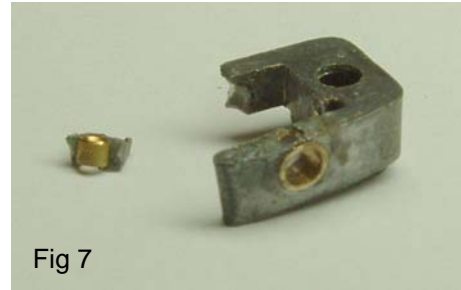
Fig 7

The winding stem/clutch wheel support block (fig 7) was also broken. This was made from a casting of a soft alloy with brass bushes inserted either side to accommodate the winding stem pivots, leaving only a thin section of the soft alloy top and bottom presenting an obvious fracture point.

This component was beyond satisfactory repair mainly due to the size and direction of the forces acting upon it and the soft alloy from which it was made did not lend itself well to having a new section keyed into it. The decision was made to make a new block to the same design as the original, but to make it from solid brass (fig 10).

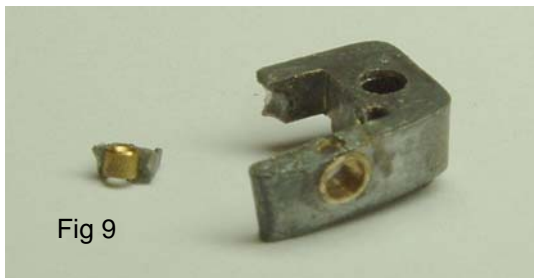
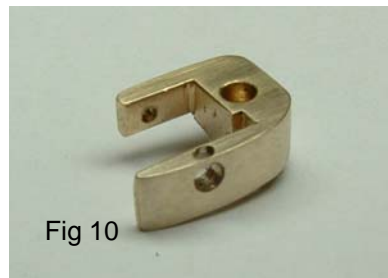
The second component was the winding stem/clutch wheel support block. The original block was made from a casting of a soft alloy, with two brass bushes inserted for the stem to pivot in. This presented a difficulty; where the bushes were fitted only a small section of the casting remained. This was not a great problem with regards to the large hole, as most of the forces acting upon it would be at right angles and extra support is given at these angles by the plates between which it is sandwiched. The pivot hole which was broken however was the small hole for the pivot at the end of the stem. This had broken due to the force exerted upon it by the stem when it was depressed to open the front cover, as this bush, in conjunction with the square on the stem acts as a stop for the winding stem. Here no additional support is provided with all of the force taken by the small section of the casting above and below the brass bush. Fig 9 shows the original block.

2 No part of the support block could be re-used; it was originally made from soft alloy which was unsuitable for attaching a new section. A replacement was made to the same design as the original but from solid brass.

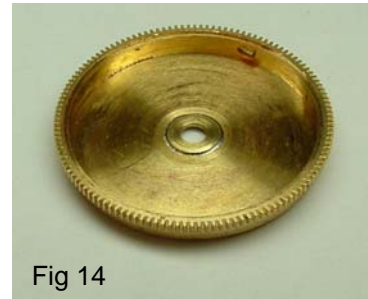
Fig 14

Besides these major faults several other points were noted; these included the need to bush the barrel, barrel cap and the barrel arbor pivot holes in the plates. The rest of the train also needed bushing with elongated holes throughout, this included pallet and balance pivot holes. All pivots were showing signs of slight wear although none, excluding the missing escape wheel pivot, were beyond repair. The wheels and pinions themselves were also showing signs of wear, all teeth and leaves were however intact, presenting no major difficulties. The blue steel mainspring was not serviceable as when removed from the barrel it only expanded to about twice the diameter of the barrel, besides being distorted in the flat, probably due to previous hand winding. The single index pin was also missing with only the single rivet left in the index. Also one case screw was missing and the head of the crown wheel screw was broken, both required replacement.

The barrel was bushed first, opening the holes to a suitable diameter and soldering brass bushes into place, the pivot holes were then broached to the correct size, checking both end and side shake (fig 14). The barrel arbor pivot holes in the plates were then bushed, keeping end and side shake to a minimum while keeping the depthing between intermediate setting wheel, cannon pinion, third wheel and minute wheel correct. The next point to be tackled was the broken escape wheel pivot, the arbor was successfully drilled and a piece of blue pivot steel fitted, this was then finished and burnished. All other train pivots were then re-finished, taking care not to reduce their diameters by any more than was necessary, in order to maintain their strength.
