A Seven Year Itch

Peter Barker describes a long-term problem, now solved – or is it?

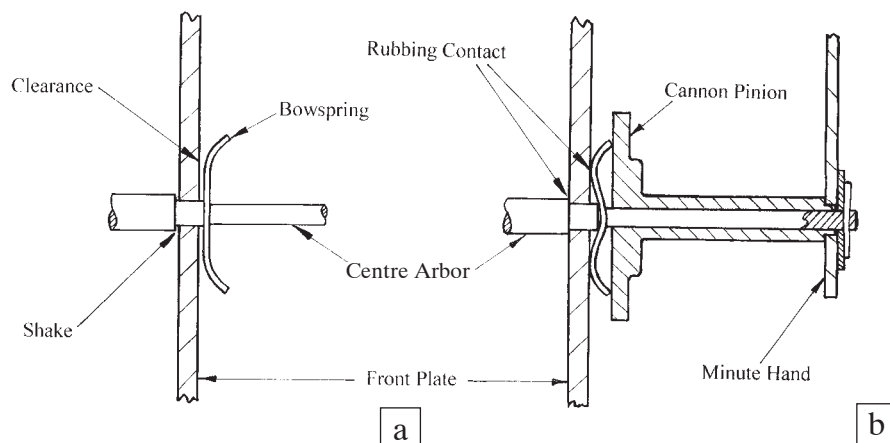
Over compression of the bow spring resulting from a short centre arbor.

I had previously checked that nothing was binding and that there was ample shake in all the arbors but now, with the hands on, I found that all shake in the centre-shaft had disappeared. Taking the motion-work down and examining the back of the bow-spring revealed a single tiny (about $\frac{1}{4}$ mm diameter) burnished spot at about half the spring's tip radius. Now I knew what to look for, I could just

In this movement, the forward extension of the centre arbor protrudes through the front plate by a relatively small amount. On re-assembly, it could be seen that, with the hands fitted, the pressure from the canon pinion was sufficient to cause the bow-spring to deflect backwards enough to rub on the front plate. In doing so, it effectively clamped the centre-arbor to the front plate, (see **1a** and **1b**).

There had never seemed to be any reason to touch the bow-spring, so it should still have been in its original condition (when it went for three years). However, to judge from the observed behaviour of the clock over the last four years or so, the frictional load that the spring was now clearly inducing in the centre-arbor must have been steadily increasing with time, presumably due to continuing creep in the bow-spring material.

With a slight reduction in the set of the bow-spring, Father Time was again nodding happily. It is gratifying that he has been doing so for a while now, but I have not yet had the courage to re-connect the passing strike.
