Unit 12 requires the candidate to make a balance staff for a platform escapement and various watch parts including a stem.

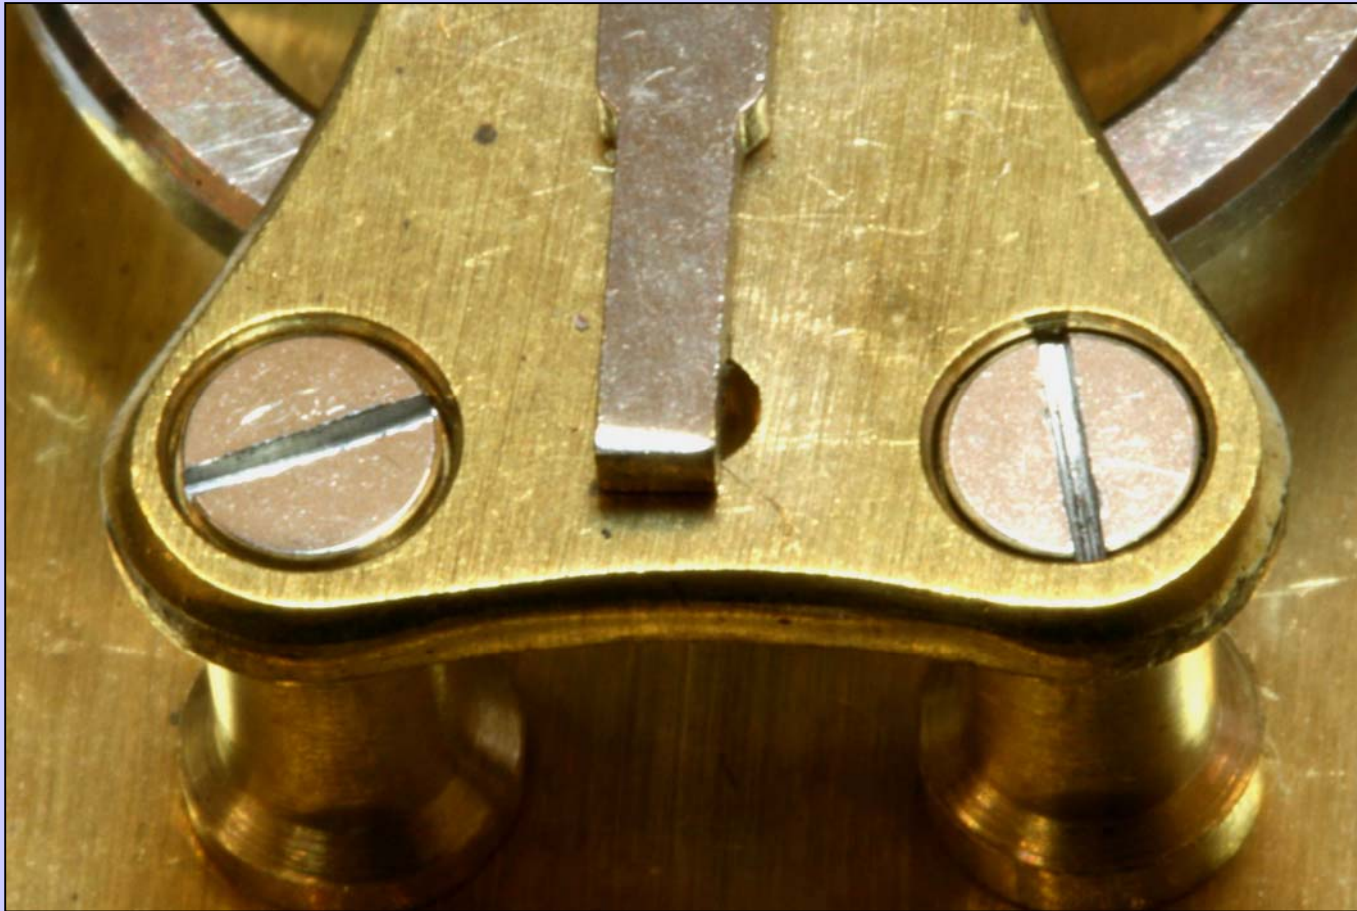
One aspect that is assessed is damage. The platform escapements are new. Avoid damaging components - screws, hairspring collet, etc..

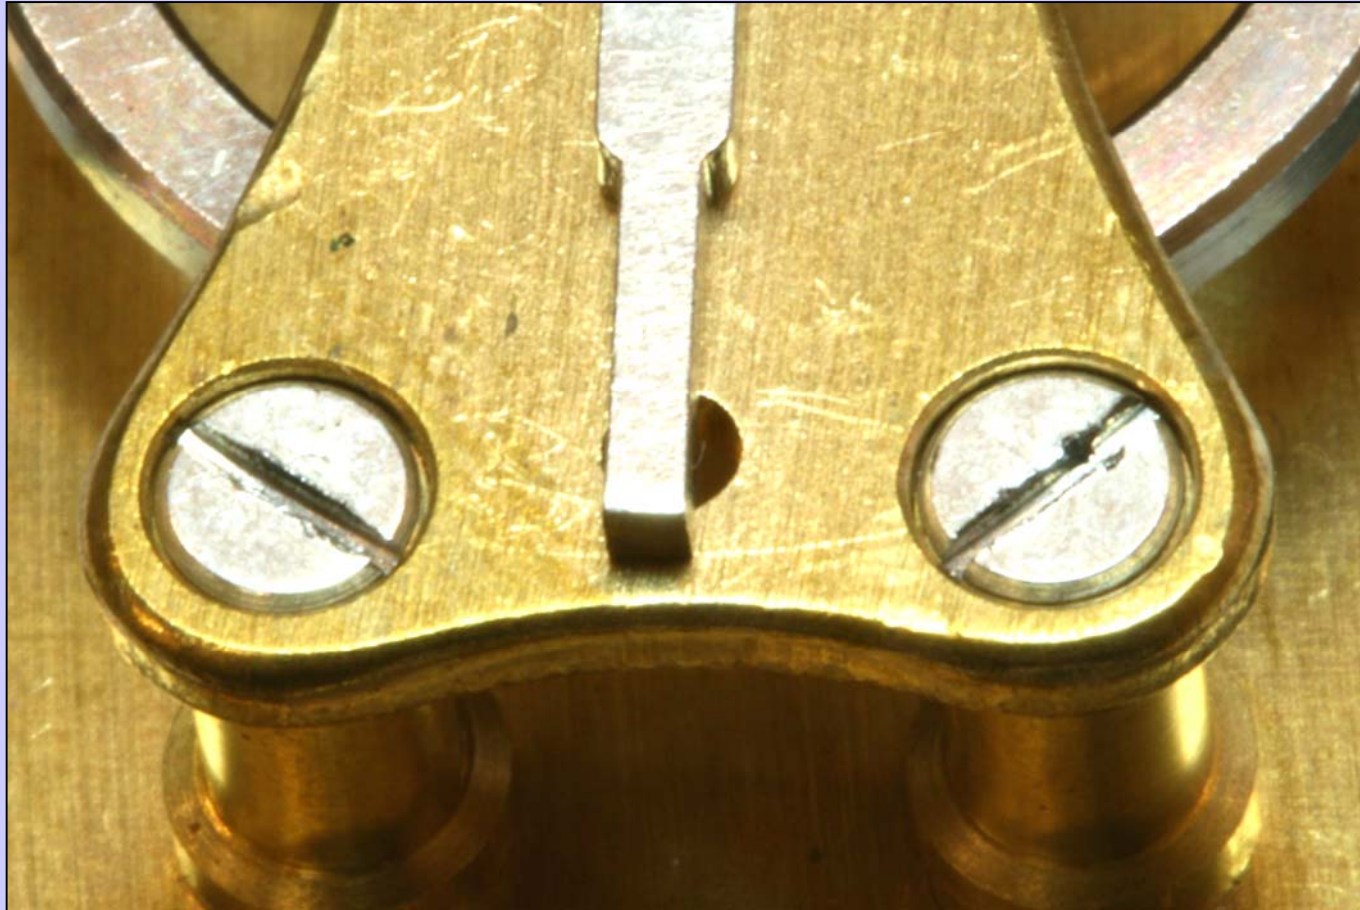
Take especial care with the screws; you will need to remove them a numbers of times. Make sure that your screwdriver fits the slot correctly.

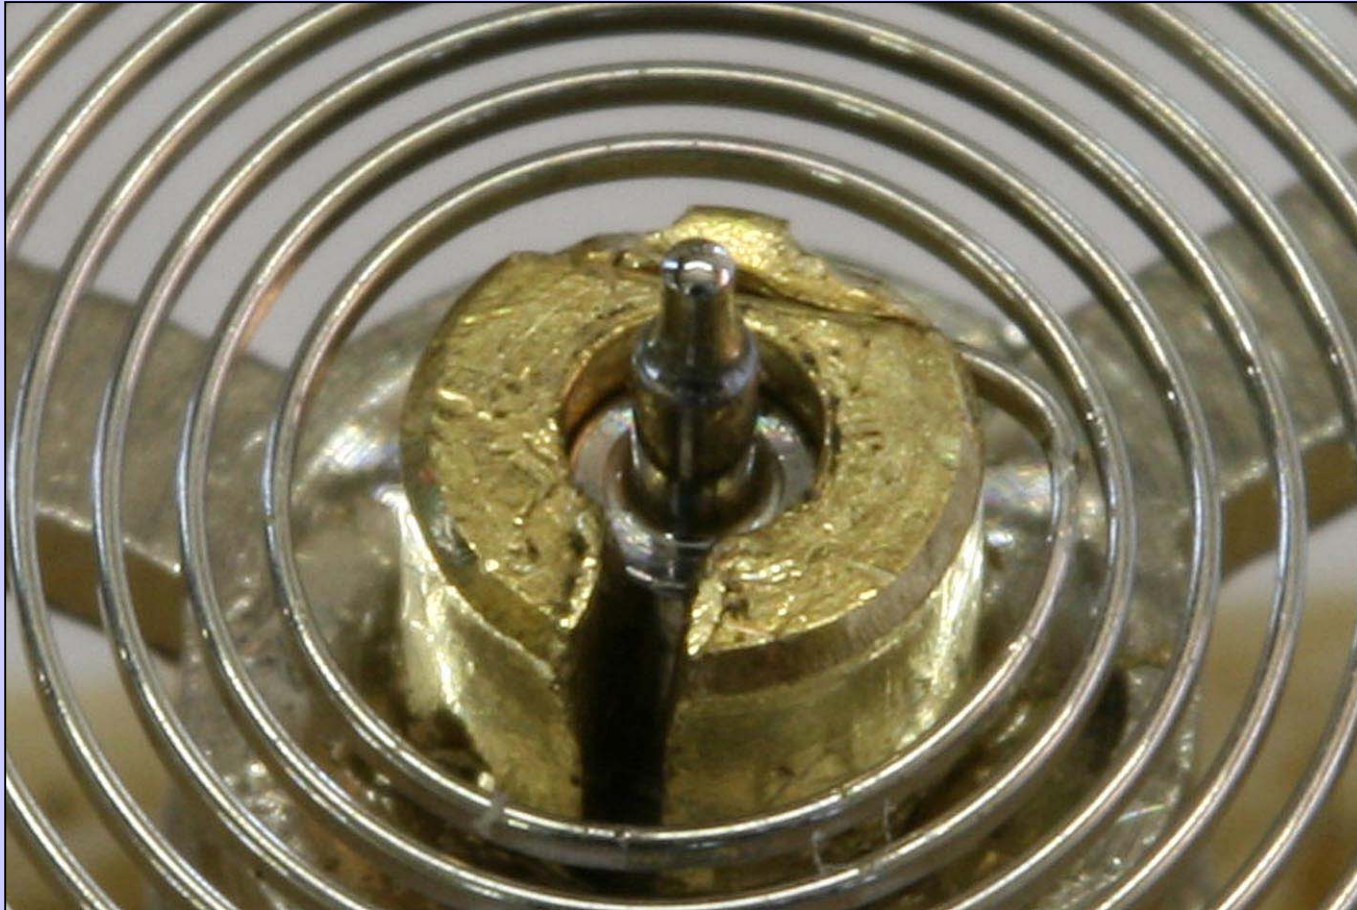
The slot in the collet has been badly damaged. Is the collet too tight on the balance staff ?

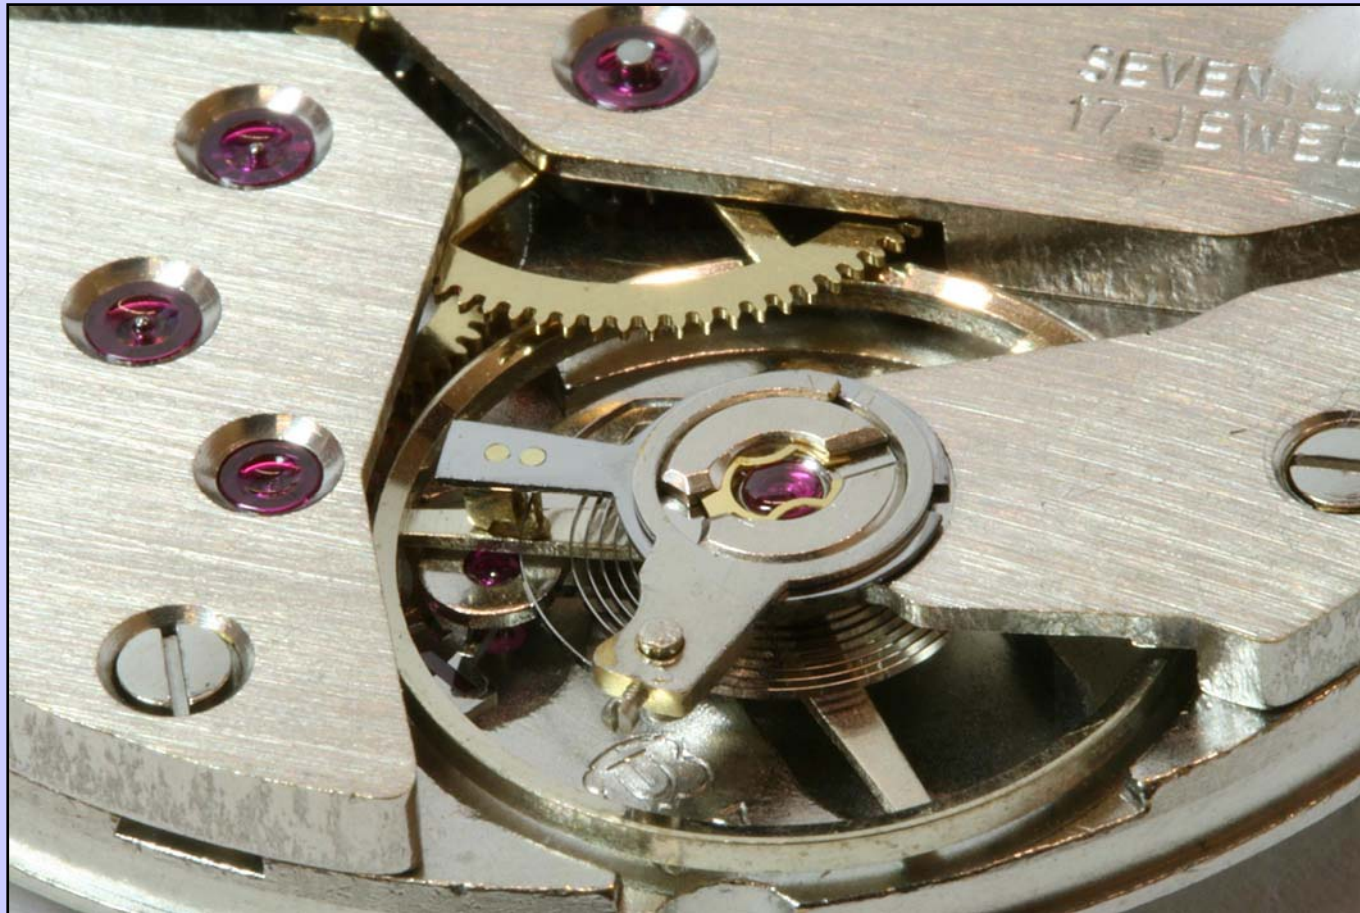
Making a new “index ring” - the boot and curb pin are neatly riveted in position and there is little sign of damage to the “stud ring”

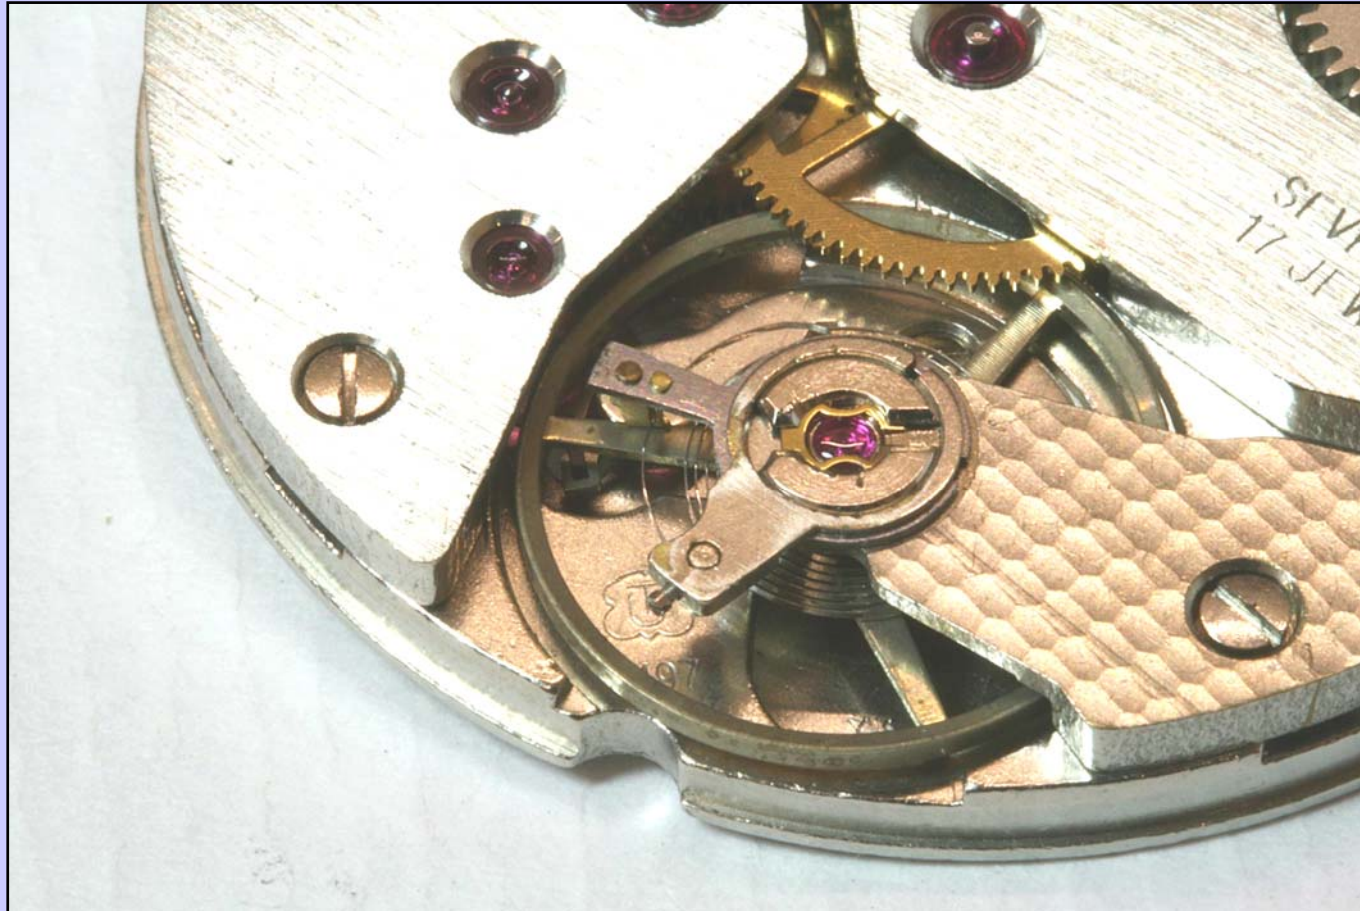
The rivets for the boot and curb pin are not equal in size and there are distinct signs of damage to the “stud ring”.

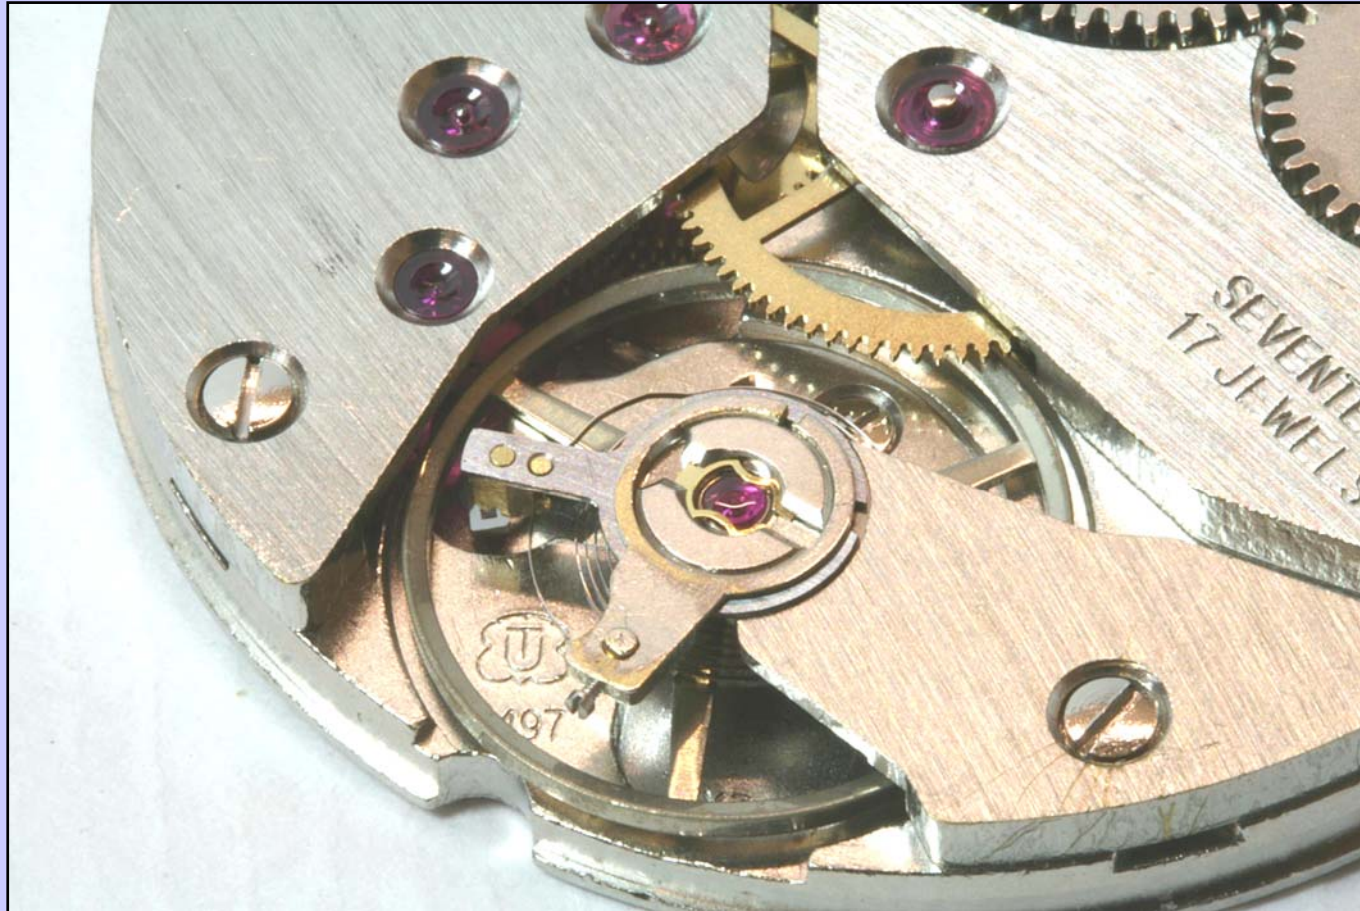
One rivet does not fill the countersink and there are definite signs of damage to the “stud ring”.

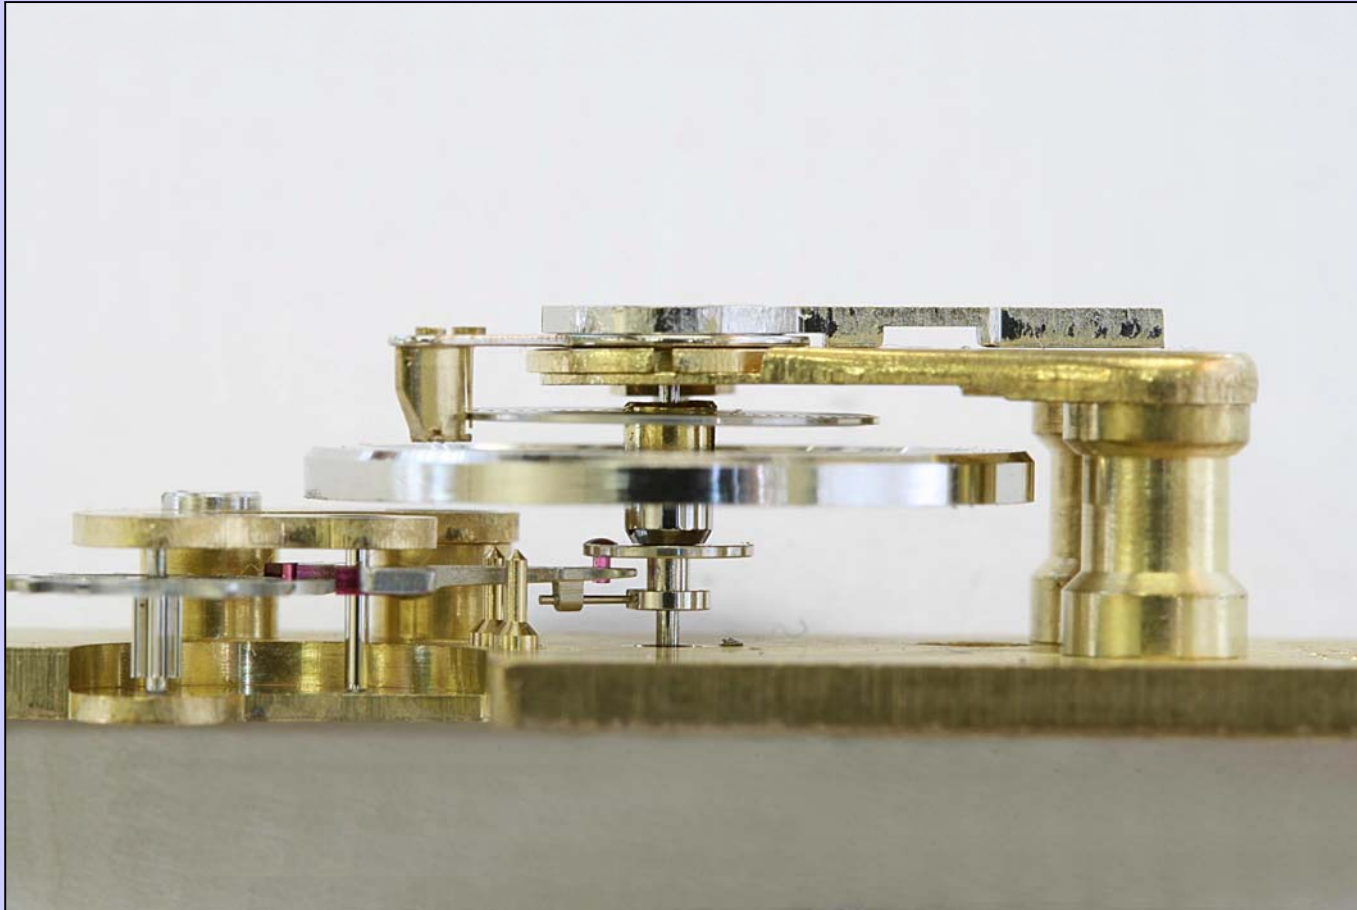
Making the balance staff. The balance spring should be flat and the guard pin aligned at the centre of the safety roller.

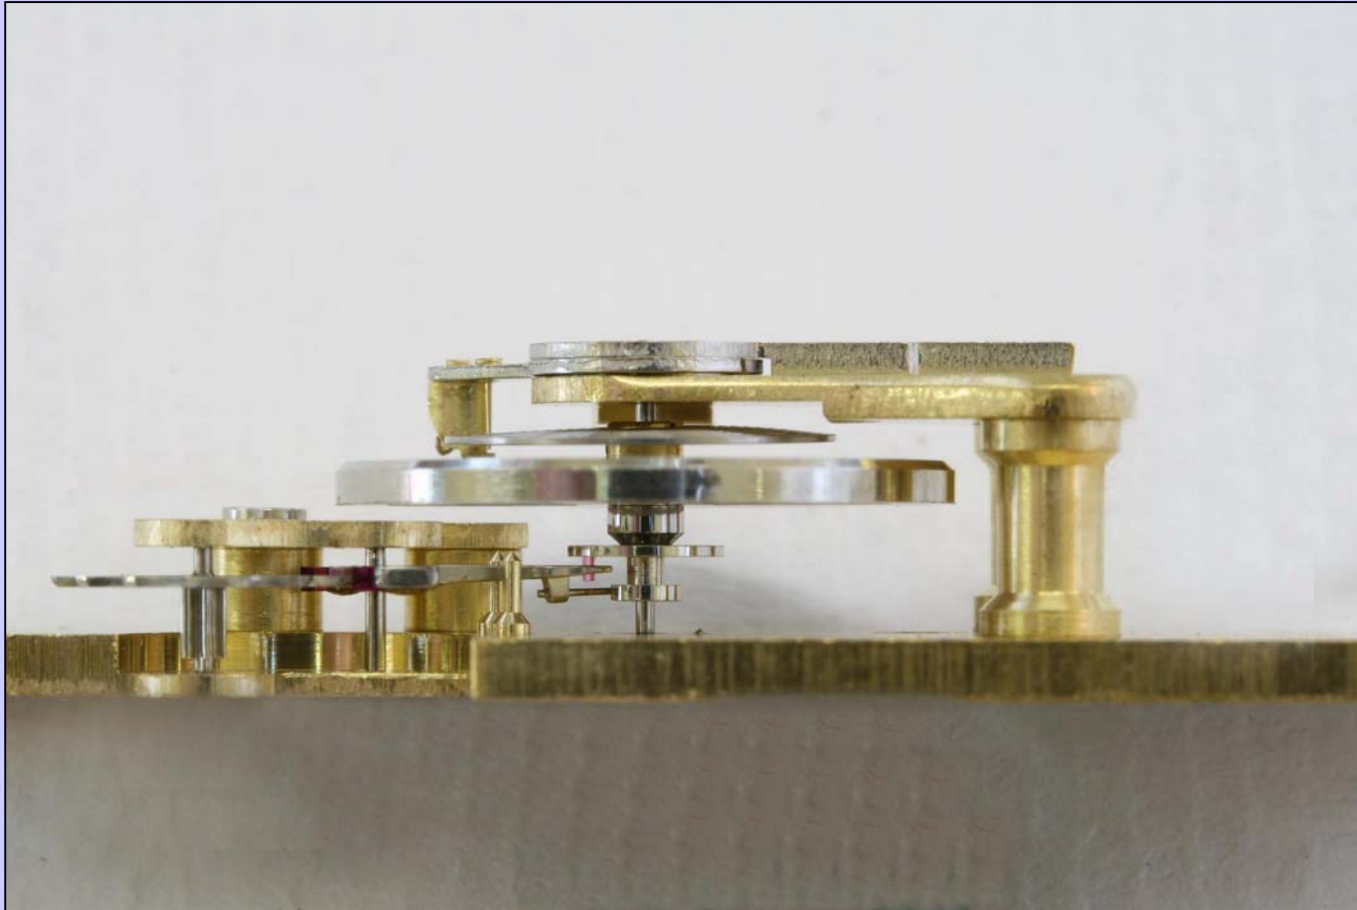
All details must be correct. This balance spring is not flat and the roller is slightly low for the guard pin.

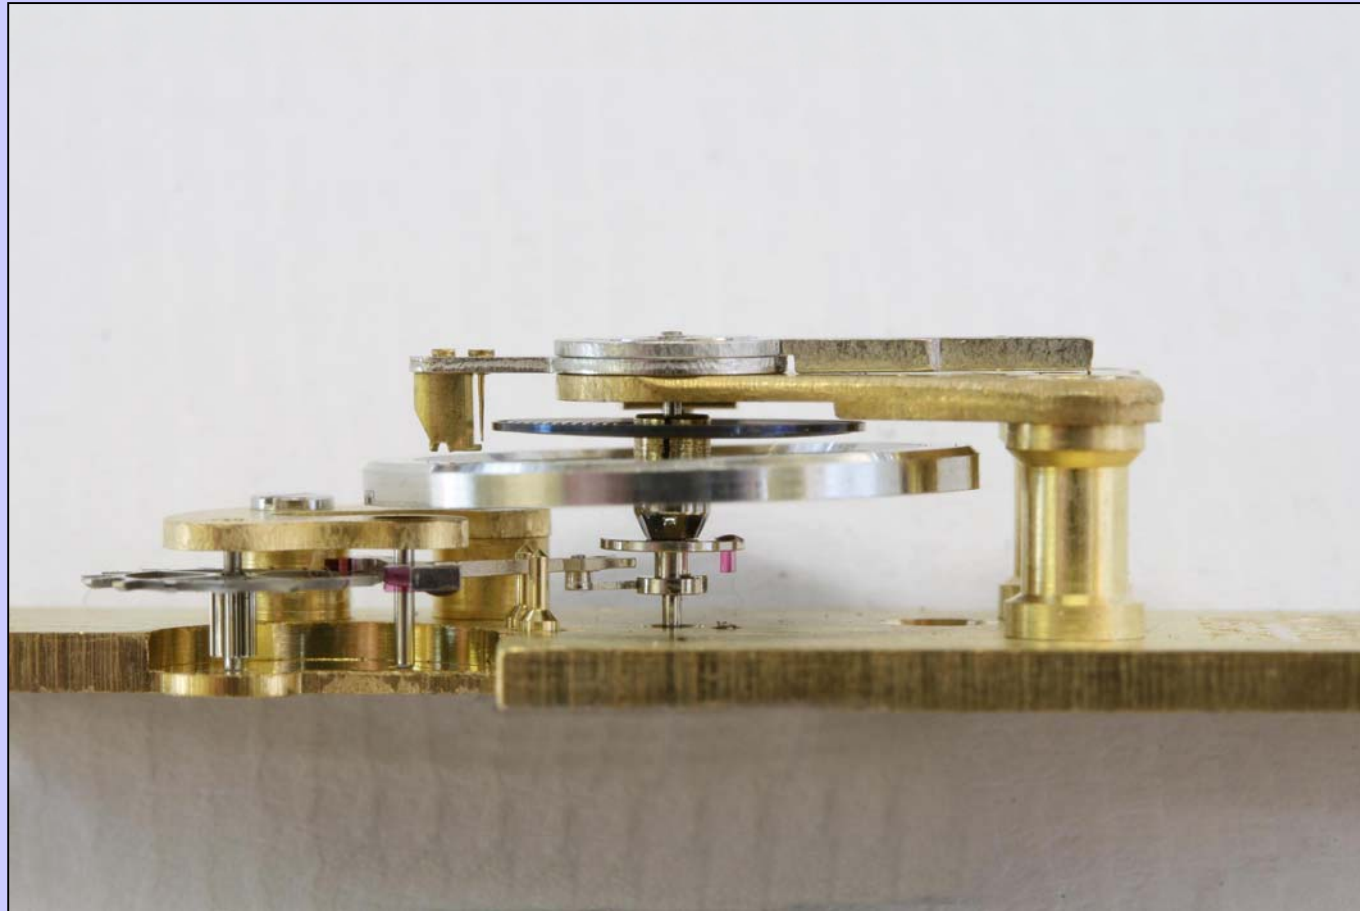
The balance is not “flat”; it is loose and the escapement has not been adjusted for beat. It would not work - not “fit for purpose”.

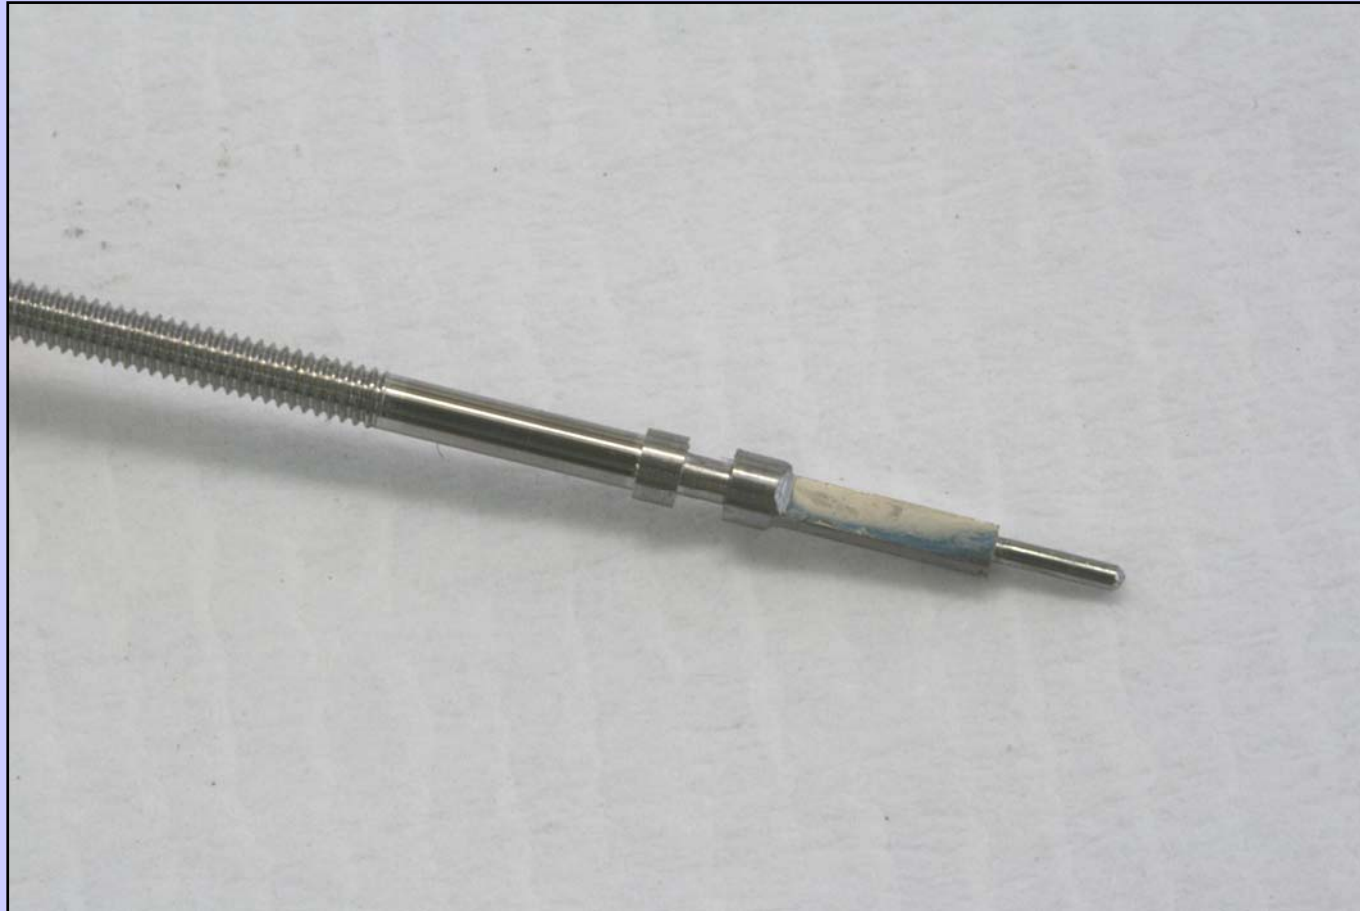
The stem is missing. Candidates make a replacement stem.
The shoulder at the end of this square is very rounded.

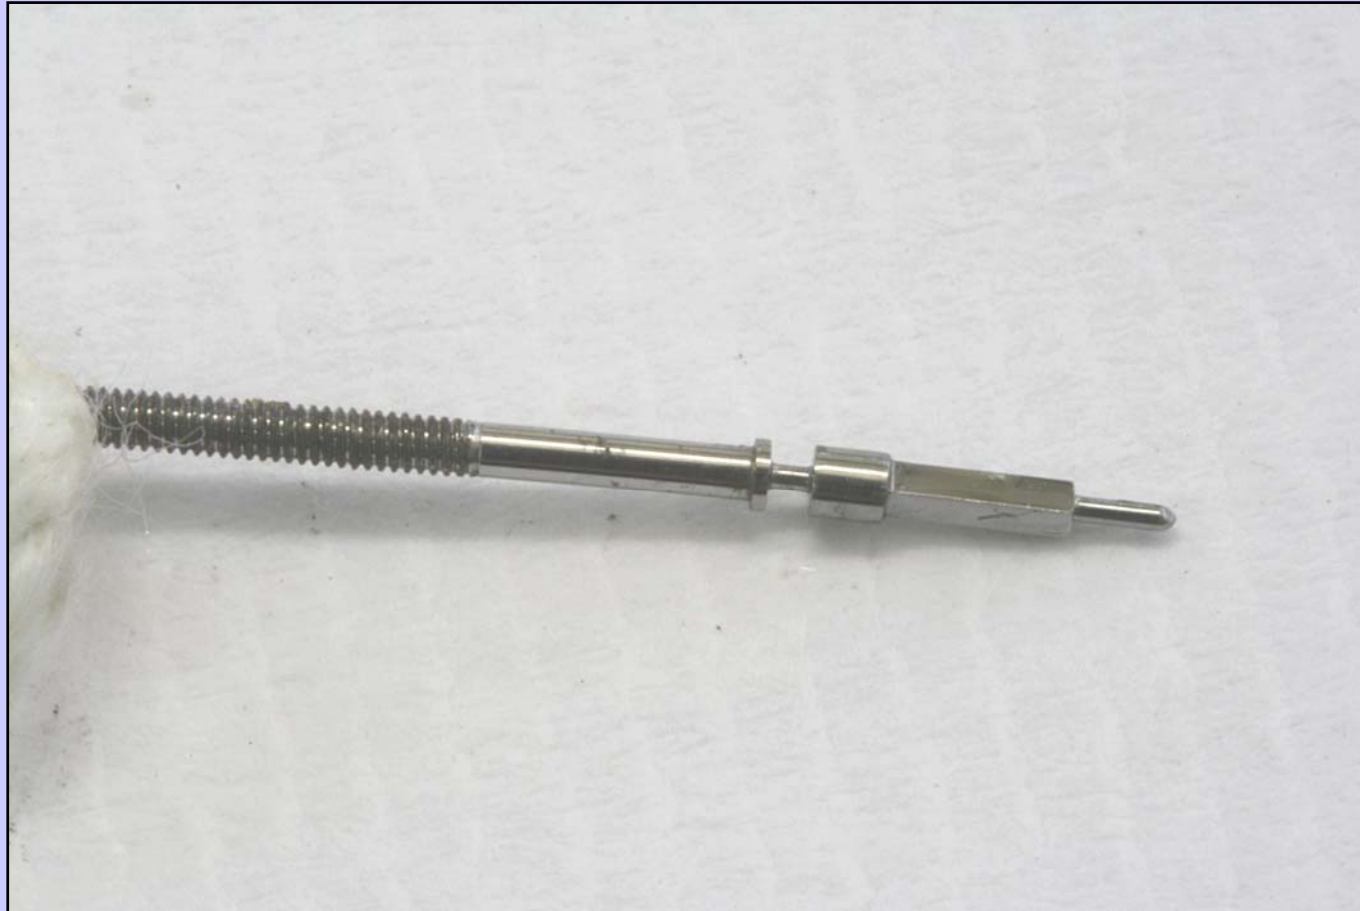
This is not “fit for purpose”. The groove which engages the setting lever is too deep making the stem very weak; scale remains after hardening.
