Restoring the Great Clock of Westminster

By Chris McKay, BSc CEng MIEE MBHI

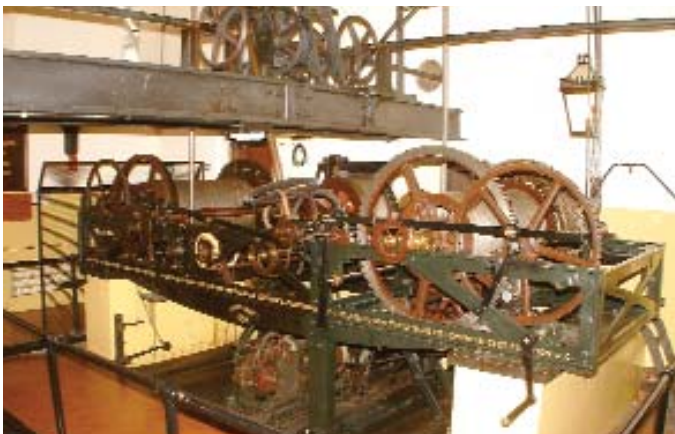
1. The Great Clock Movement: Striking train on the left, going in the centre and quarter striking on the right. The vertical flies are out of view above the movement.

The morning of Saturday 11th August 2007 was a busy one at the Palace of Westminster (Houses of Parliament) with a large collection of media to witness the commencement of an extensive programme of maintenance on the Great Clock popularly called 'Big Ben' **Photos 1 & 2**.

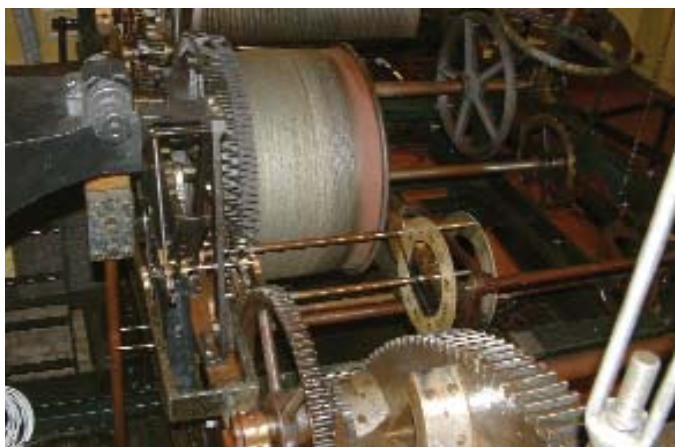
2. Top view of the movement. At the back the quarter barrel can just be seen. In the centre is the going barrel with its train and escapement. Note the two wheels on the going barrel, the great wheel on the left, the right one is a winding wheel on the barrel itself. In the foreground the cams of the hour striking barrel can be seen along with one wheel of the striking train.

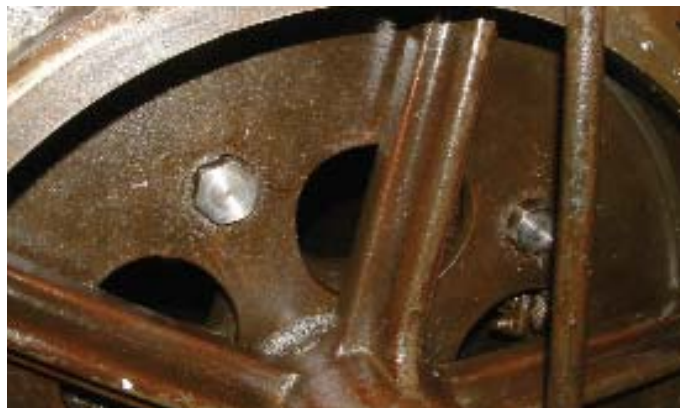
Why was such extensive maintenance work needed? Wear had been noticed in the striking train where the strike barrel was seen to be rubbing on the great wheel during winding **Photo 3**. On the going train the lantern pinion trundles on the 'scape were getting deeply pitted, so that was another indicator that work was needed, **Photos 4, 5, & 6**. In 1913 a motor-assisted winding mechanism had been installed below the movement; this too was showing wear, in one place needing attention. No significant work had been carried out on the striking or going trains for many years.

3. Rear view of the hour striking barrel. The bolt heads that secure the cam wheel onto the barrel cap were found to be rubbing on the great wheel. As a temporary measure, the bolt heads were reduced slightly.

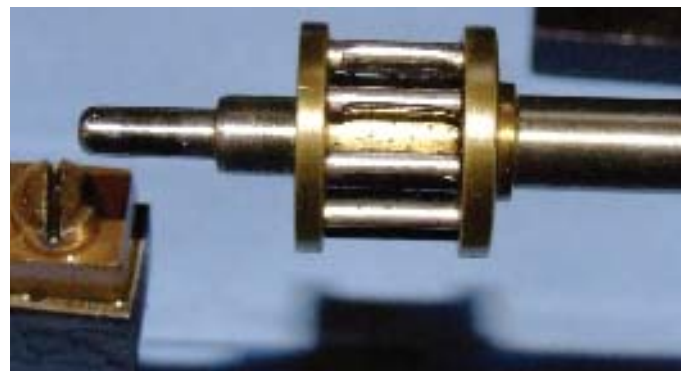
4. Escape wheel pinion, note the wear on the trundles.

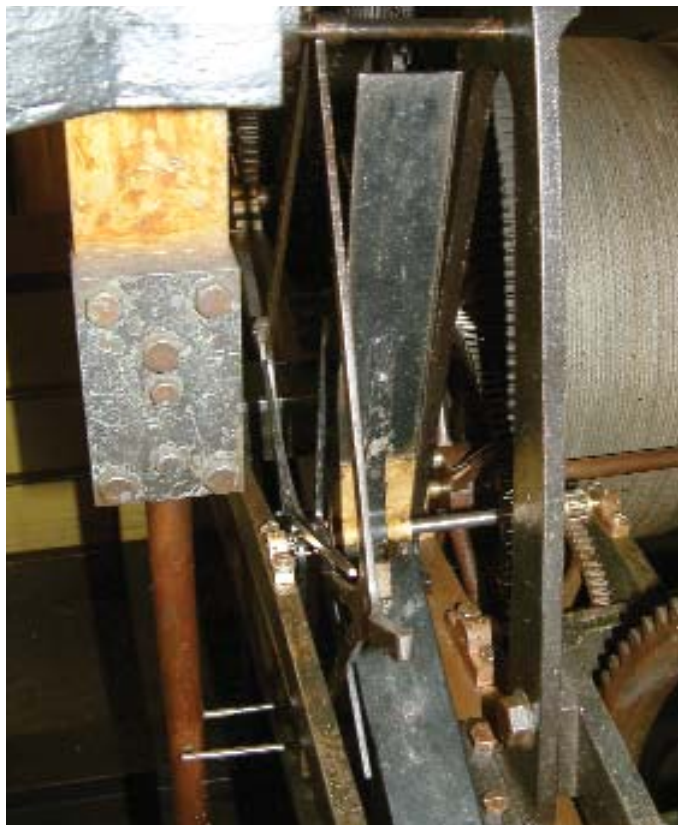
5. The escapement. The Westminster clock is somewhat unusual since it has a three-bladed fly on the 'scape wheel.

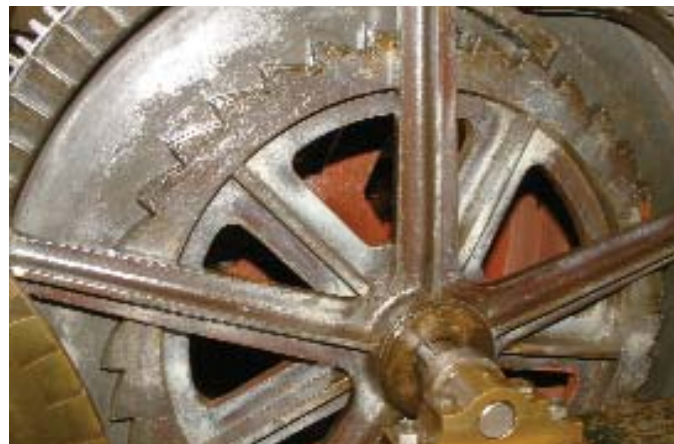
6. The end of going barrel. Note the key that is one of three that retain the great wheel on its arbor. Ratchet-like teeth on the side of the wheel are part of the very effective maintaining power system unique to the Great Clock

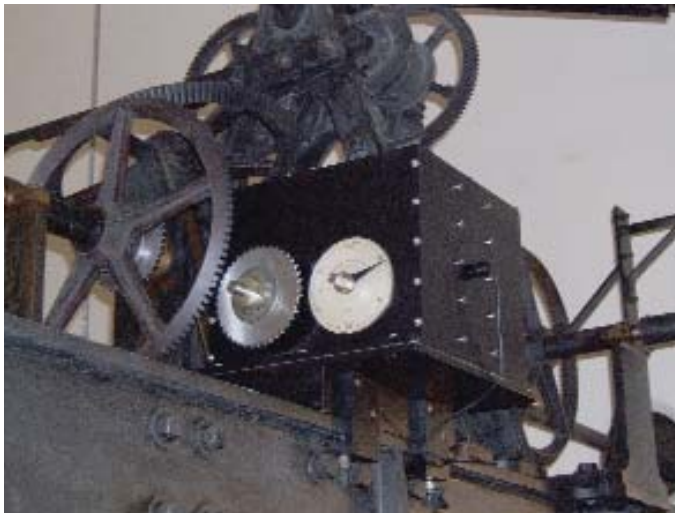
8. Synchronous motor drive unit.

Since it was decided to keep the hands telling the time, an early task was to specify a synchronous drive unit that would neatly fit next to the bevel gear cluster, **Photo 8**. It had to be very powerful but still be easily engaged and disengaged as needed. In good weather it is quite easy to turn the hands on one dial by the pressure of a few fingers on the counterbalance, but get a good gale at the 180 feet above street level and the requirement for driving force dramatically increases. A special synchronous unit was commissioned, built, tested at full load, and installed in the tower the week before the major work started. Fuller details of this special unit will appear in a later article.

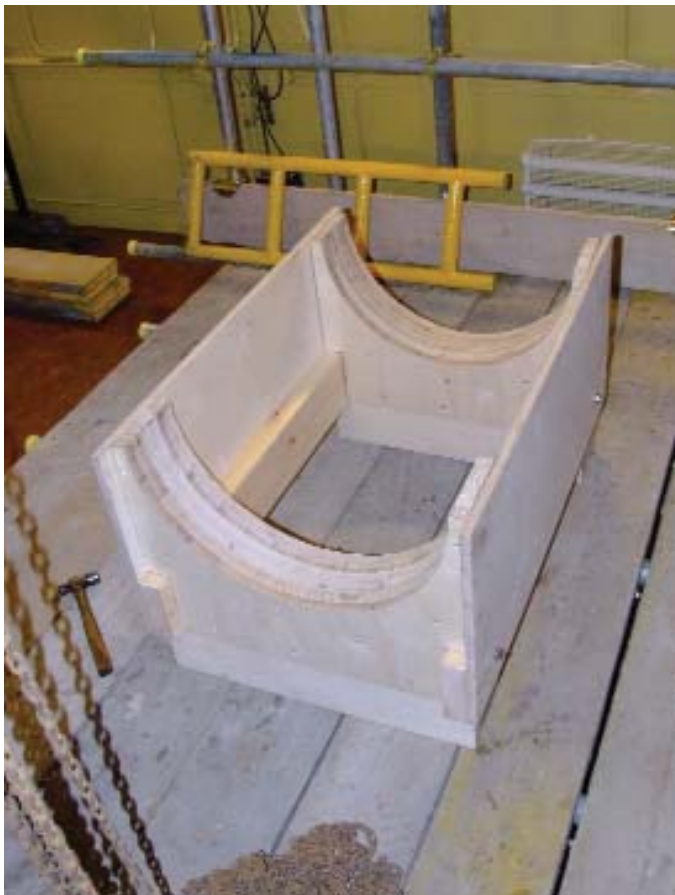
9. Cradle for strike barrel.

The next exercise was the design and building of two robust wooden cradles, **Photo 9**, that would be used to support the striking and going barrels when they had been removed from the clock. These were also to be used for transporting the barrels and for holding them during dismantling and re-assembly.

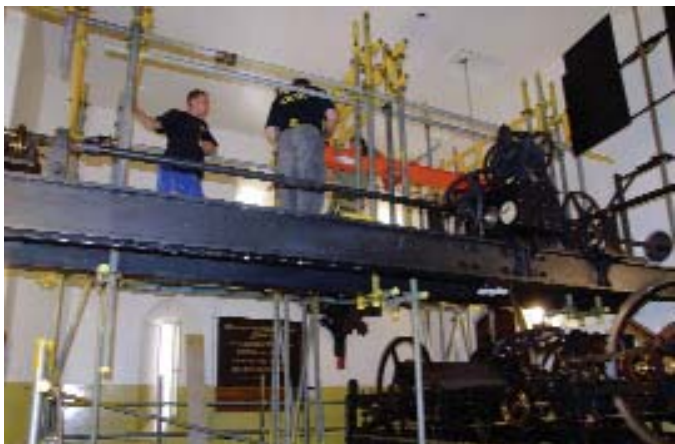
10. Putting up the scaffolding to enable the lifting of heavy parts.

Since the combined weight of the striking barrel, great wheel, arbor and winding wheel is around $\frac{3}{4}$ ton, careful thought had to be paid to how it would be lifted out of the frame. A custom-built scaffold with lifting chain blocks, **Photo 10**, running on a girder was the solution. However, this could not be installed until the clock was stopped and delicate items like the escapement removed. Again a contractor was employed for this specialist work. Along with the scaffolding, duckboards were to be laid on the deck to protect the floor and anything that had to be rested there.

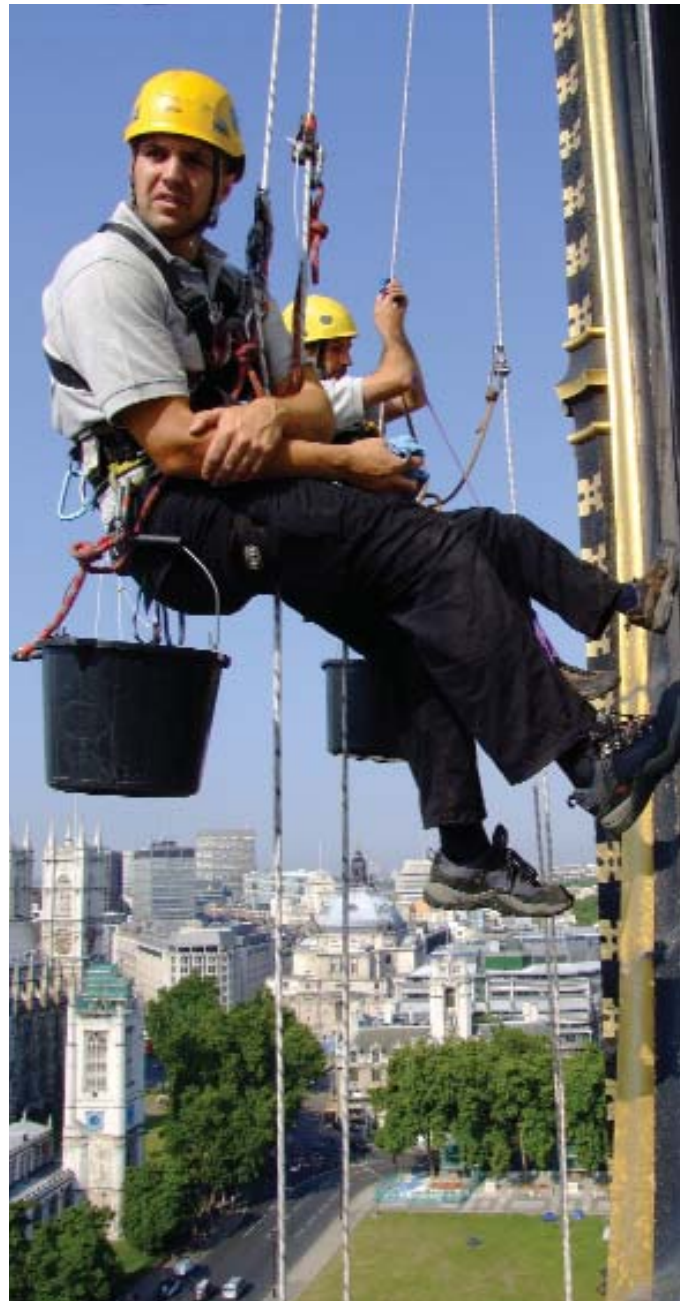
11. A brief break to admire the view whilst cleaning the dial.

Normally the dials need cleaning every three years and this is done by a team of abseilers complete with good old-fashioned buckets and sponges, **Photo 11**. Inevitably repairs would be needed to the odd pane of glass and where putty had fallen prey to the vicious action of freezing and thawing; this would be replaced with silicone rubber.

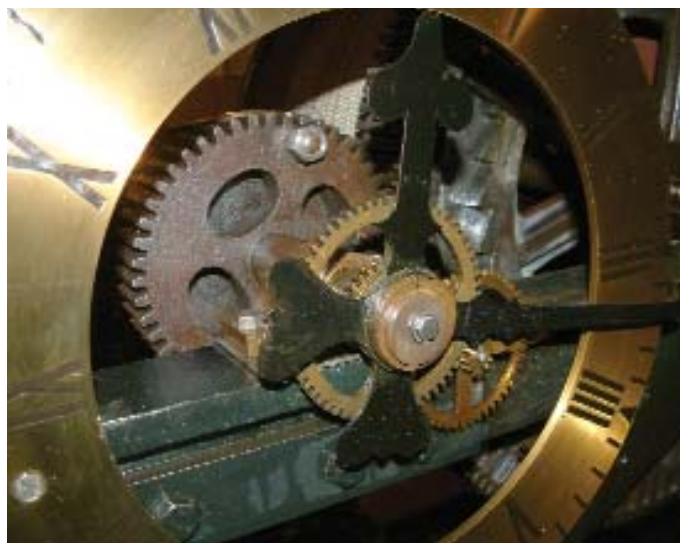
12. A rarely-seen view. The internal setting dial at the rear of the clock. The nut on the gear wheel is one of the two that clamp up the hand setting mechanism.

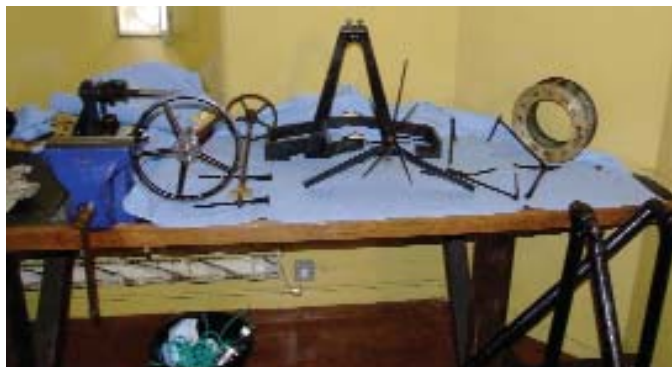
13. The dismantled escapement.

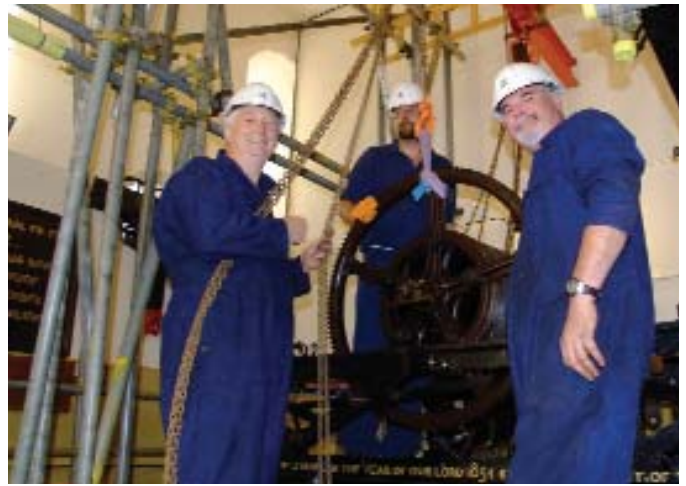
15. Paul, Huw and Ian lifting out the hour striking barrel.

Once the scaffolding was assembled the huge striking barrel was then slowly lifted from its bearings with a couple of chain blocks, **Photo 15**. It was then eased forward in front of the clock and lowered into the waiting cradle. Safely at rest, the winding wheel was removed, **Photo 16**, and the great wheel and its arbor slid out. These three items were then carefully wrapped for the descent down the stair well. Lowering the barrel went smoothly, **Photo 17**, but when the great wheel with its arbor was about half way down the tower it would not pass the hand rails. No doubt some quirk of the building or difference with the handrails had stolen a valuable inch. With the winch taking the weight, the great wheel had to be man-handled out of the well and into the stair area. Once a turn of the stairs had been negotiated, the well was again of sufficient width to accommodate lowering the great wheel.

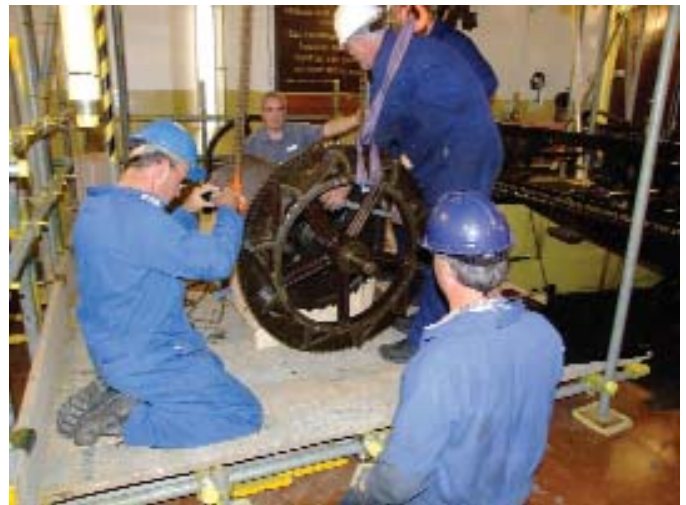
16. Safely in its cradle, the great wheel and arbor is removed from the hour the striking barrel.

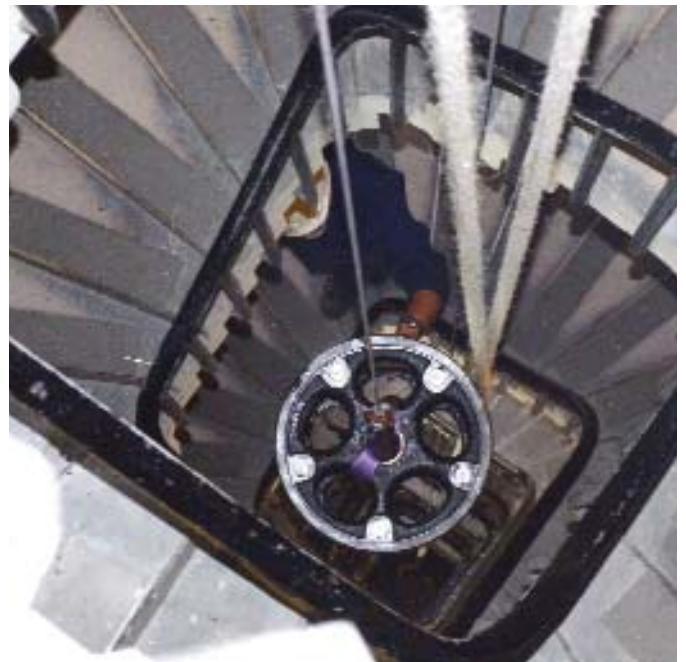
17. The striking barrel being lowered down the stair well.
